Testing Specialties Inc. – Building Systems Commissioning

**Project Name: Beverly Hills Hotel Renovation Case Study**

**The following notations were taken from actual field notes taken by our Commissioning Agent on just one construction issue:**

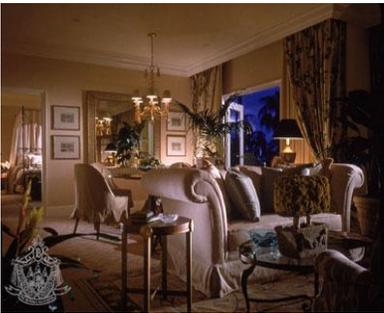
Beverly Hills Hotel - Wing

The TSI Commissioning Agent began to inspect the duct segments as they were being installed and noted that as each segment was butted up the next adjoining duct section, that the ends of the internal duct liner was being compressed or in some cases voids being left.

**Problem observed:** Internal duct lining was not being sealed properly at the ends of each duct section as it was being installed. If this problem was not corrected, the result will be; as the Air Handling Unit (AHU) is started, the air velocity in the ductwork will tear away the liner, which will lodge on the ductwork elbow turning vanes, thus causing major air distribution problems. Since much of this ductwork is being installed in inaccessible locations, a fix is needed.

**Recommended fix:** TSI recommended that each section of the liner be sealed as each section is being installed to insure continuous integrity of the duct liner. The ductwork was modified to allow access. A duct installer actually worked inside the duct installing and sealing the duct behind him as the sections were being installed, in smaller ducts, access doors were used to access the affected duct liner joints.
